Consultant's Advice Note – Bowden Hall - Tree Safety

Doc No: CAN/01

Structural Safety Assessment of Residual Sycamore Trees

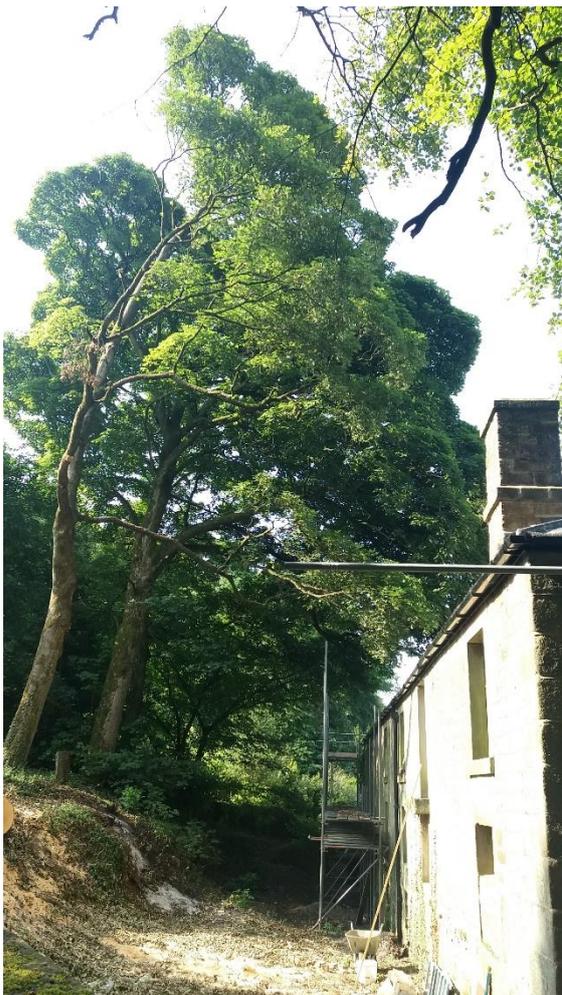
BACKGROUND – It is understood that Nigel Webb was undertaking measures to protect the listed fabric of the original hall building at Bowden Hall (SK23 0QP) by removing a number of mature sycamore trees close to the building and which were, at the time, unprotected by TPO / TPZ status. These works were then reported to High Peak Borough Council, and subsequently temporary TPOs have been put in place in order to allow a period of review as to what best to do with the remaining trees (see photograph below).

OBSERVATIONS ON SITE – originally there appear to have been a stand of 6 mature sycamore trees, of which only 3 now remain.

As a result of the partial removal of the stand the remaining trees are now more exposed to potential storm damage. Because the trees were closely planted this has affected their individual growth potential and the remaining trees are now unbalanced, in that the canopies are eccentric. Whilst this was the case prior to the removal of the 3 more easterly trees, there is now no effective 'group sheltering' effect.

CONCLUSIONS & RECOMMENDATIONS – There is significant risk to both listed fabric and human life should the original hall building be occupied during a significant storm event. It would therefore be prudent not to commence permanent residency until the remaining trees have been removed as originally intended.
